WEST VALLEY COLLEGE (WVC) FACILITIES (F) BUILDING - IN SITU REPAIR OF EXISTING FACADE

WEST VALLEY MISSION COMMUNITY COLLEGE DISTRICT,
14000 FRUITVALE AVENUE, SARATOGA CA 95070
AVENUE, SARATOGA CA 95070

The following scope of work is for a nonstructural maintenance project to restore exterior walls at West Valley College Facilities building in Saratoga, California. Unless otherwise noted, work occurs at all elevations of the building, the second-floor concrete landing, and roof skylights. Work on the project shall consist of, but is not limited to, the following:

TITLE SHEET

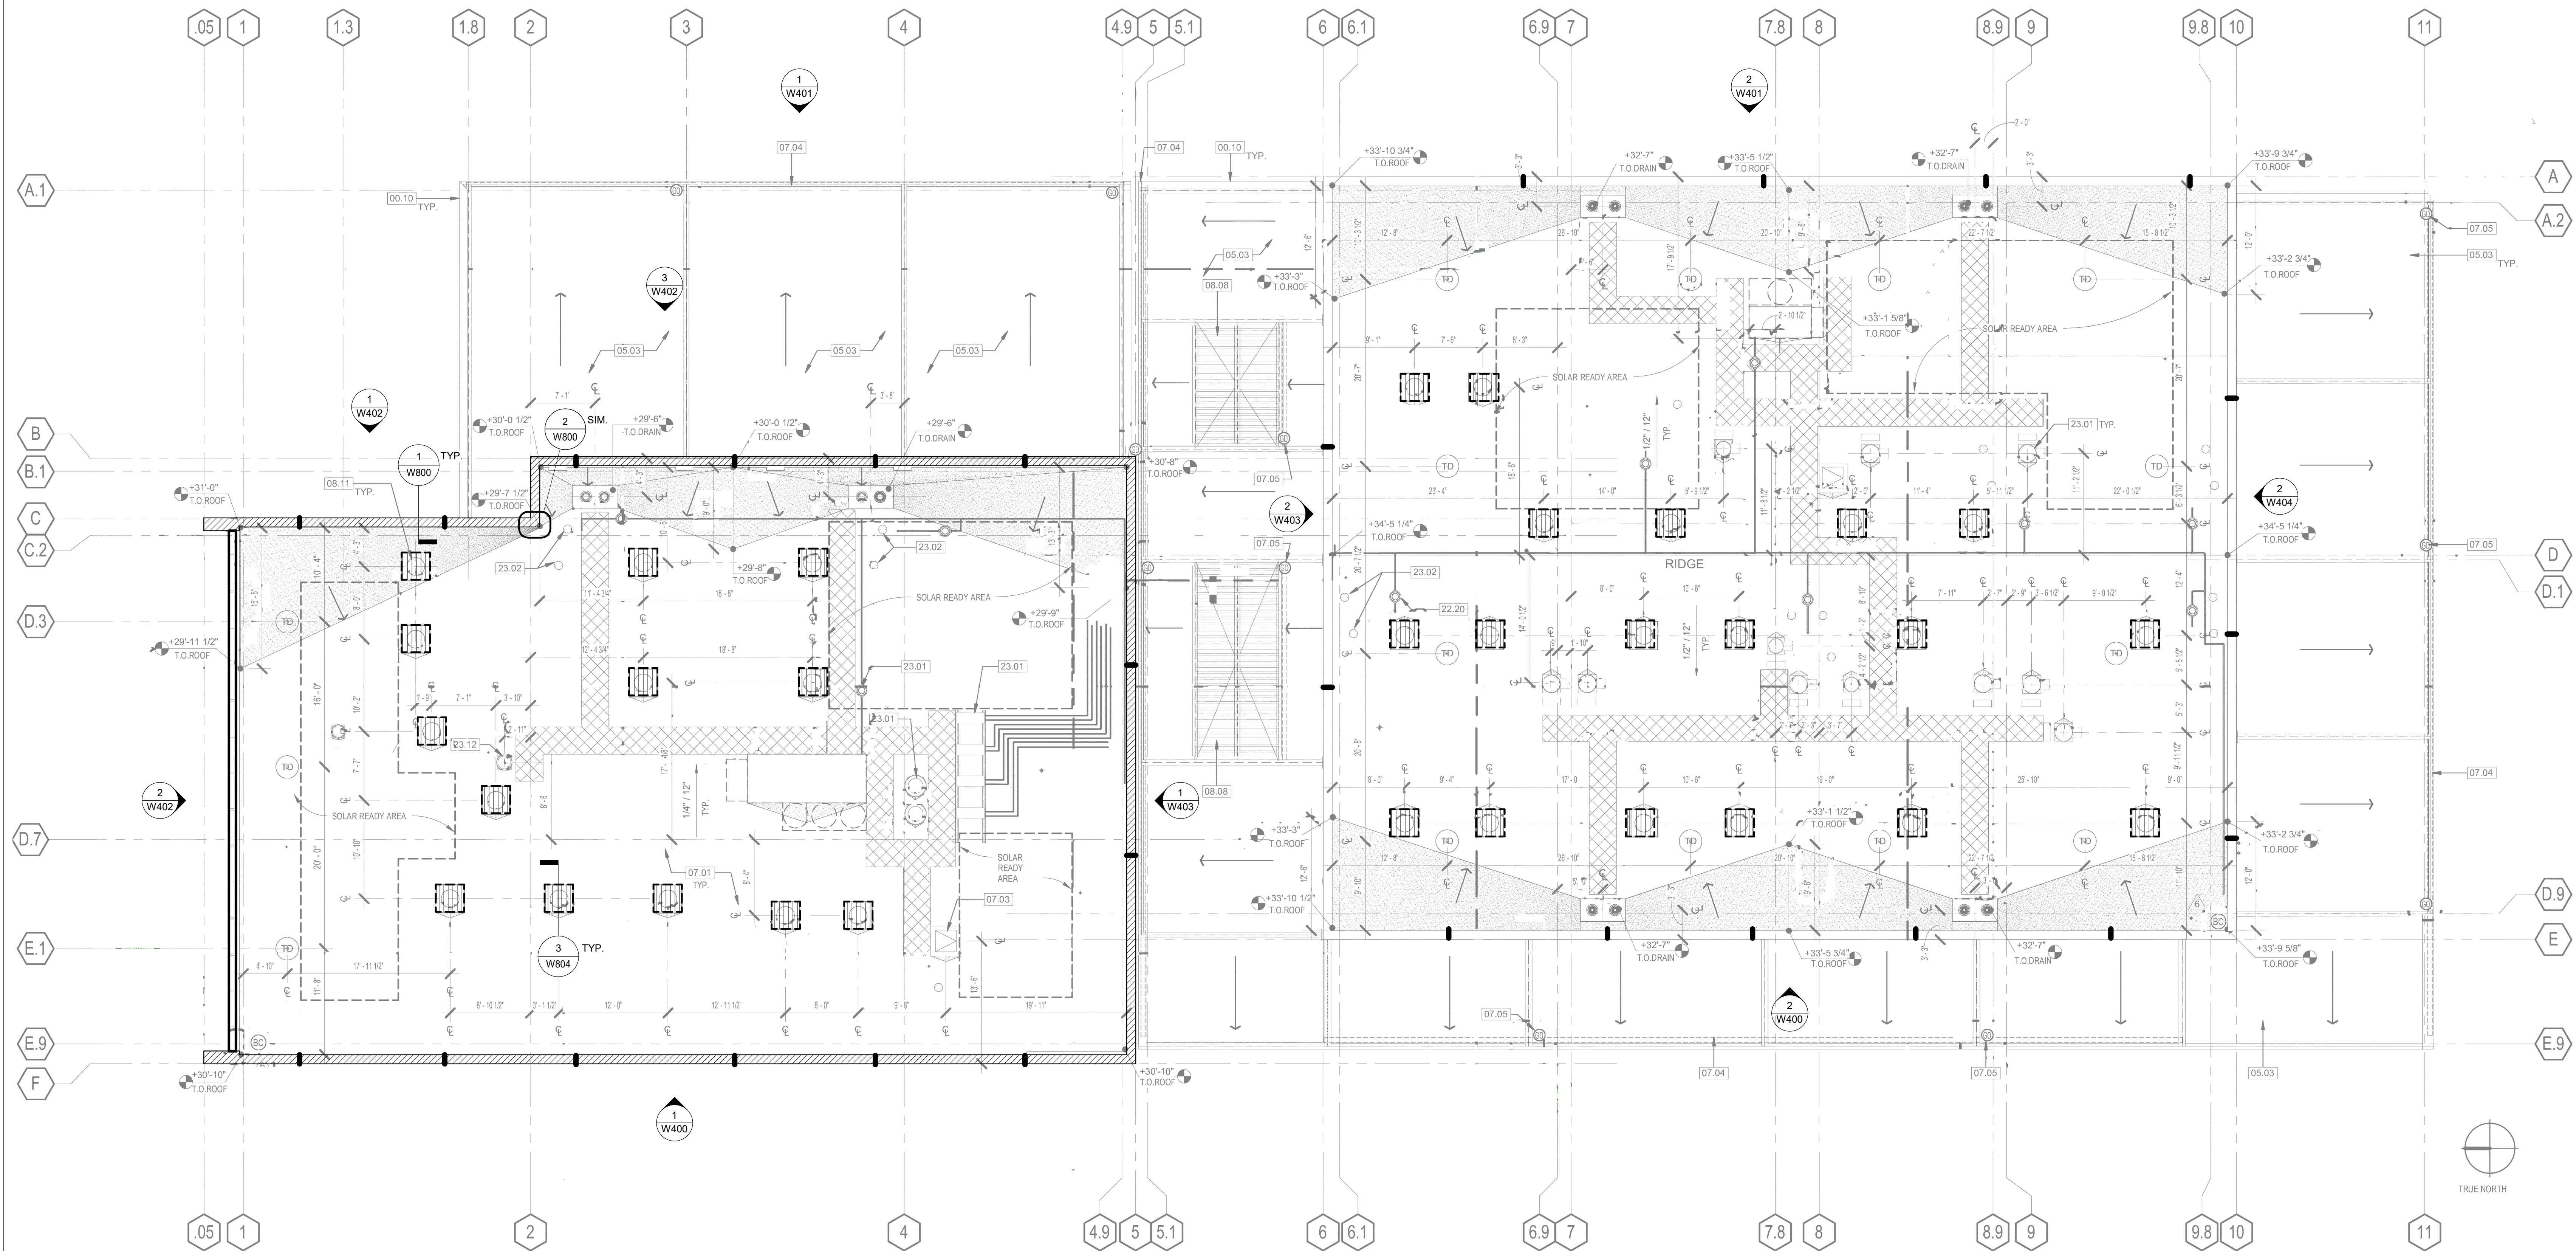
1 ROOF PLAN
 1/8" = 1'-0"

- CMU WALL**
 PROVIDE WATER-REPELLANT SEALER AT ALL EXTERIOR CMU SURFACES. PRIOR TO SEALER INSTALLATION, SURVEY ALL CMU BLOCKS TO IDENTIFY CRACKS. ROUTE AND SEAL STATIC CRACKS WITH EPOXY AND ROUTE AND SEAL DYNAMIC CRACKS WITH SEALANT.

- CONTROL JOINTS**
 INJECT EPOXY TO FILL VOIDS IN CONTROL JOINTS AND REPLACE 1" DEPTH OF EXISTING CONTROL JOINT MORTAR WITH SEALANT OVER BACKER ROD.
- GLAZED FENESTRATIONS**
 REMOVE AND INSTALL A NEW WEATHERSEAL AT THE HORIZONTAL CAPLESS JOINTS AT THE WEST ELEVATION. AT THE WEST ELEVATION, EVALUATE HARDWARE AT THE OPERABLE WINDOW WHERE LEAKAGE WAS OBSERVED DURING WATER TESTING. OBTAIN THE WINDOW/CURTAIN WALL MANUFACTURER'S APPROVAL FOR THE PROPOSED REPAIR PRIOR TO INSTALLATION.
 SURVEY REMAINING OPERABLE WINDOWS FOR THE DEFECT THAT IS THE SOURCE OF LEAKAGE AND REPAIR WHERE SIMILAR DEFECT IS IDENTIFIED.
 AT ALL WINDOWS, NOZZLE TEST HORIZONTAL TO VERTICAL JOINTS AND REPLACE JOINTS WHERE LEAKAGE IS OBSERVED.

- CONCRETE FOUNDATION WALL**
 ROUTE AND SEAL CONCRETE CRACKS WITHIN THE VERTICAL EXTENT OF THE THICKNESS OF THE SLAB. EXTEND THE PENETRATING SEALER USED FOR THE CMU REPAIRS ONTO THE CONCRETE TO COVER THE FACE OF THE CONCRETE SLAB.

- CMU PARAPET WALL**
 IMPLEMENT CMU WALL REPAIR AT THE BACK SIDE OF ALL EXPOSED CMU PARAPET SURFACES.
- ROOF SKYLIGHT**
 INSTALL SILICONE TAPE BED IN SILICONE SEALANT TO SEAL THE TRANSITION BETWEEN SKYLIGHT AND ROOFING SHEET METAL COUNTERFLASHING.

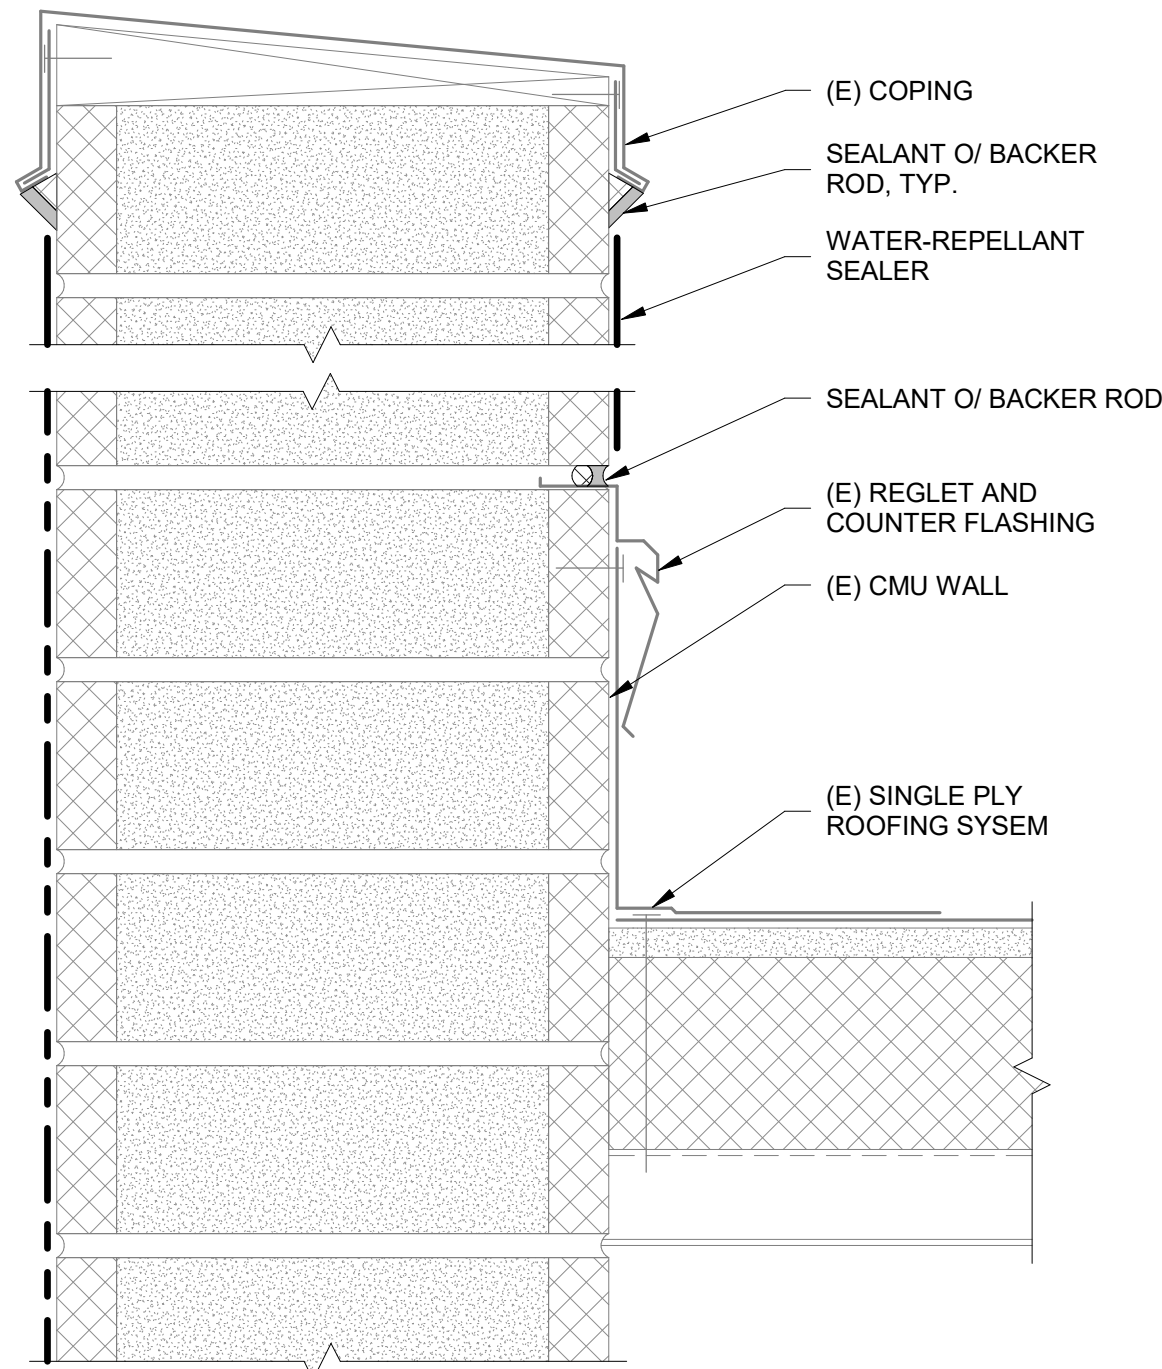
1 CMU PARAPET WALL
 NTS

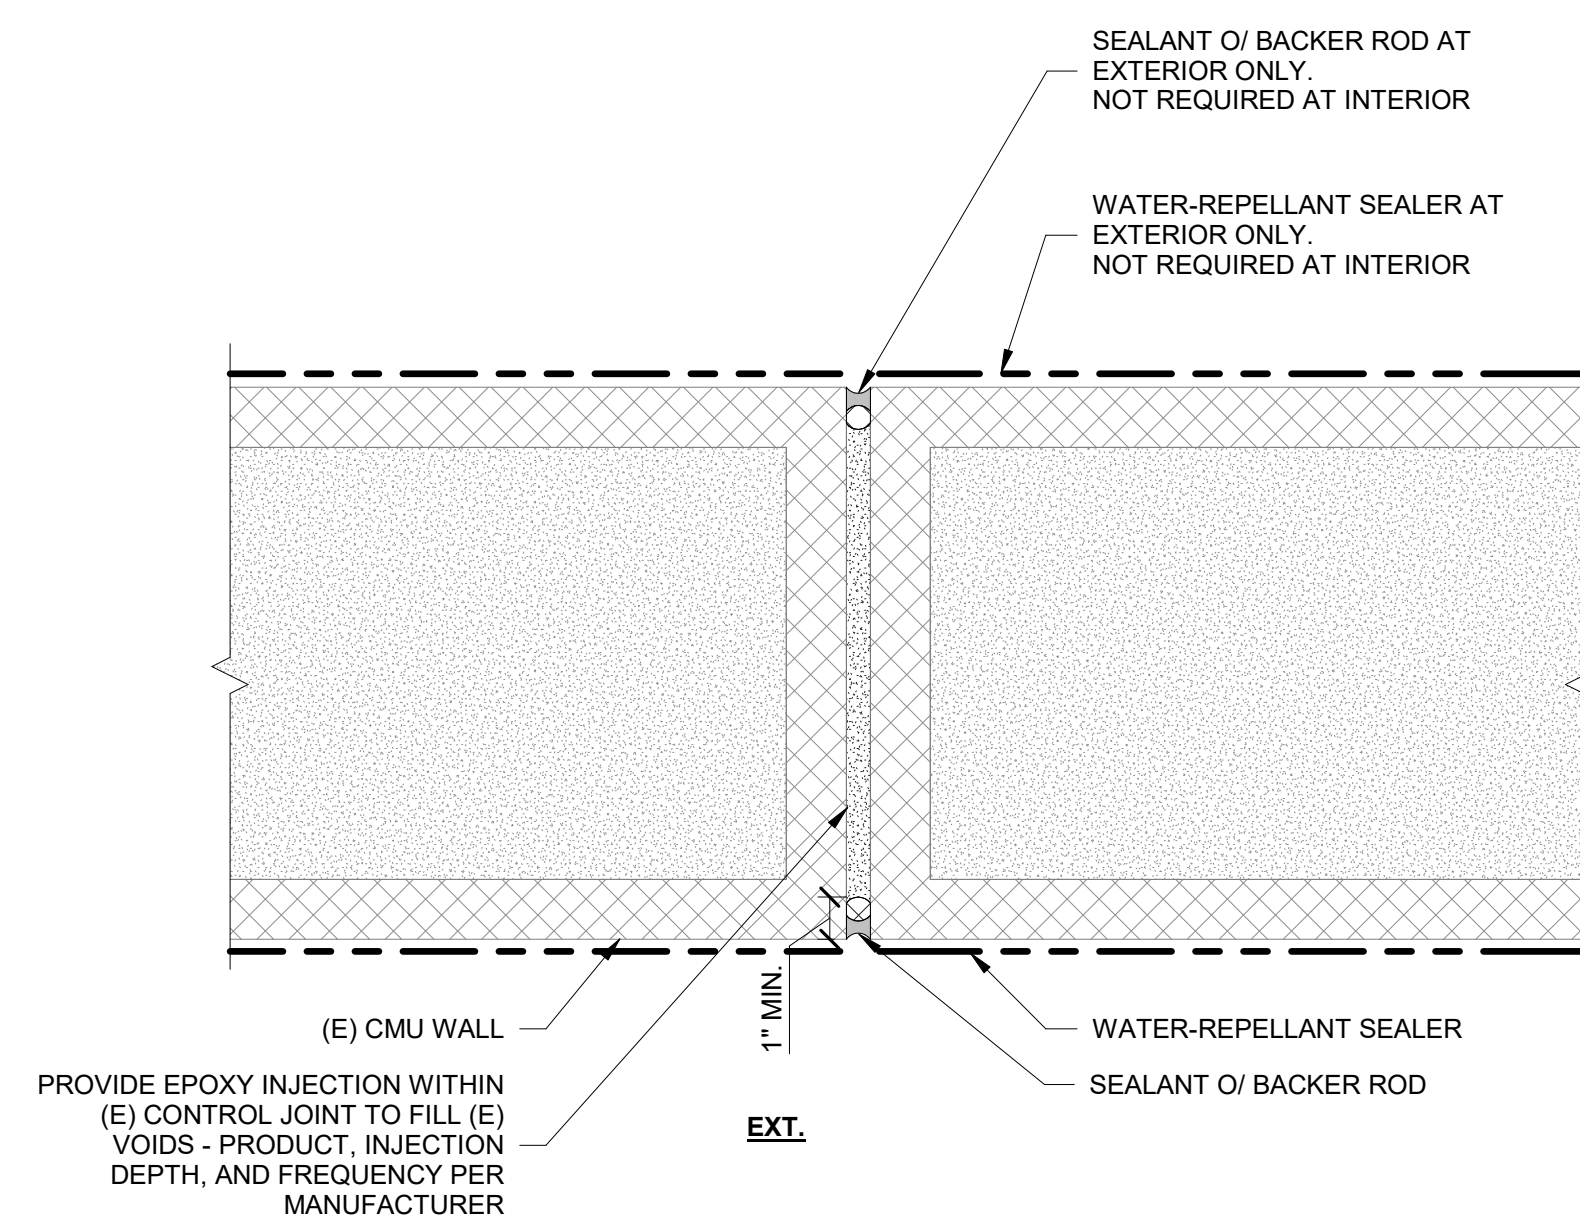
2 CONTROL JOINT AT CMU WALL
 NTS

- Survey 100% of the CMU walls for cracks and submit survey to the Engineer-of-Record.
- Inject with epoxy identified cracks in the survey and at locations indicated in the drawings. Refer to Detail 2/W800.
- Seal the exterior surface of the crack with sealant over backer rod. Refer to Detail 2/W800.
- Coat 100% of CMU walls, including the back of CMU parapet walls, with a penetrating sealer.

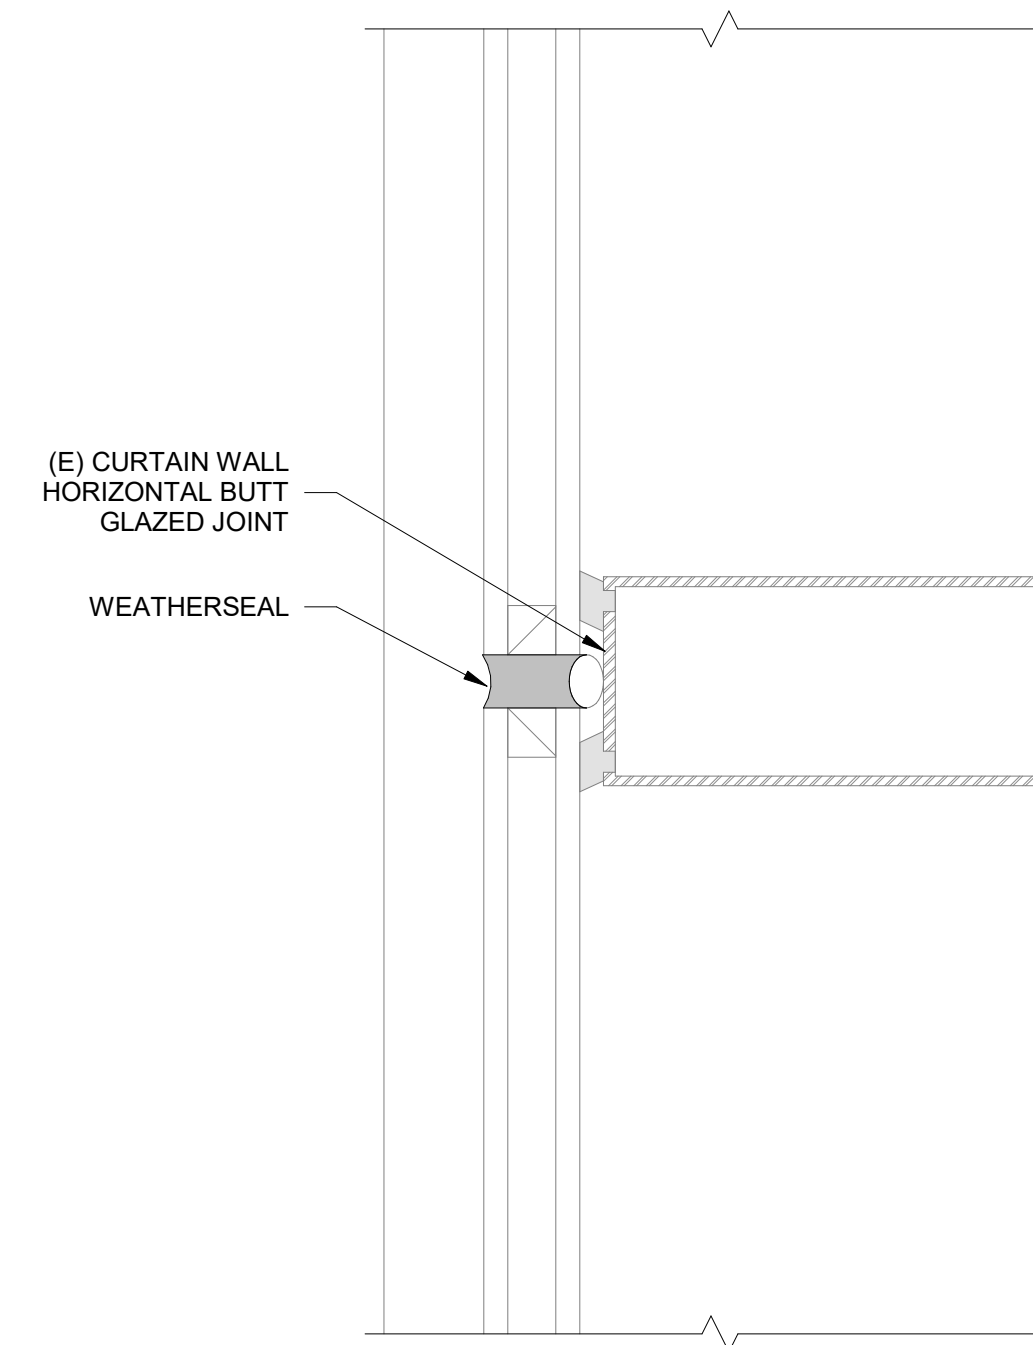
6 WEATHERSEAL AT HORIZONTAL BUTT GLAZED JOINT
 NTS

- Remove and replace weatherseal at the horizontal butt glazed joints at the West Elevation. Refer to Detail 6/W803.
- At the West Elevation, evaluate hardware at the operable window where leakage was observed during water testing.
- Obtain the window/curtain wall manufacturer's approval for the proposed repair prior to installation.
- Survey remaining operable windows for the defect that is the source leakage and repair where similar defect is identified.
- At all windows, nozzle test horizontal to vertical joints and replace joints where leakage is observed.

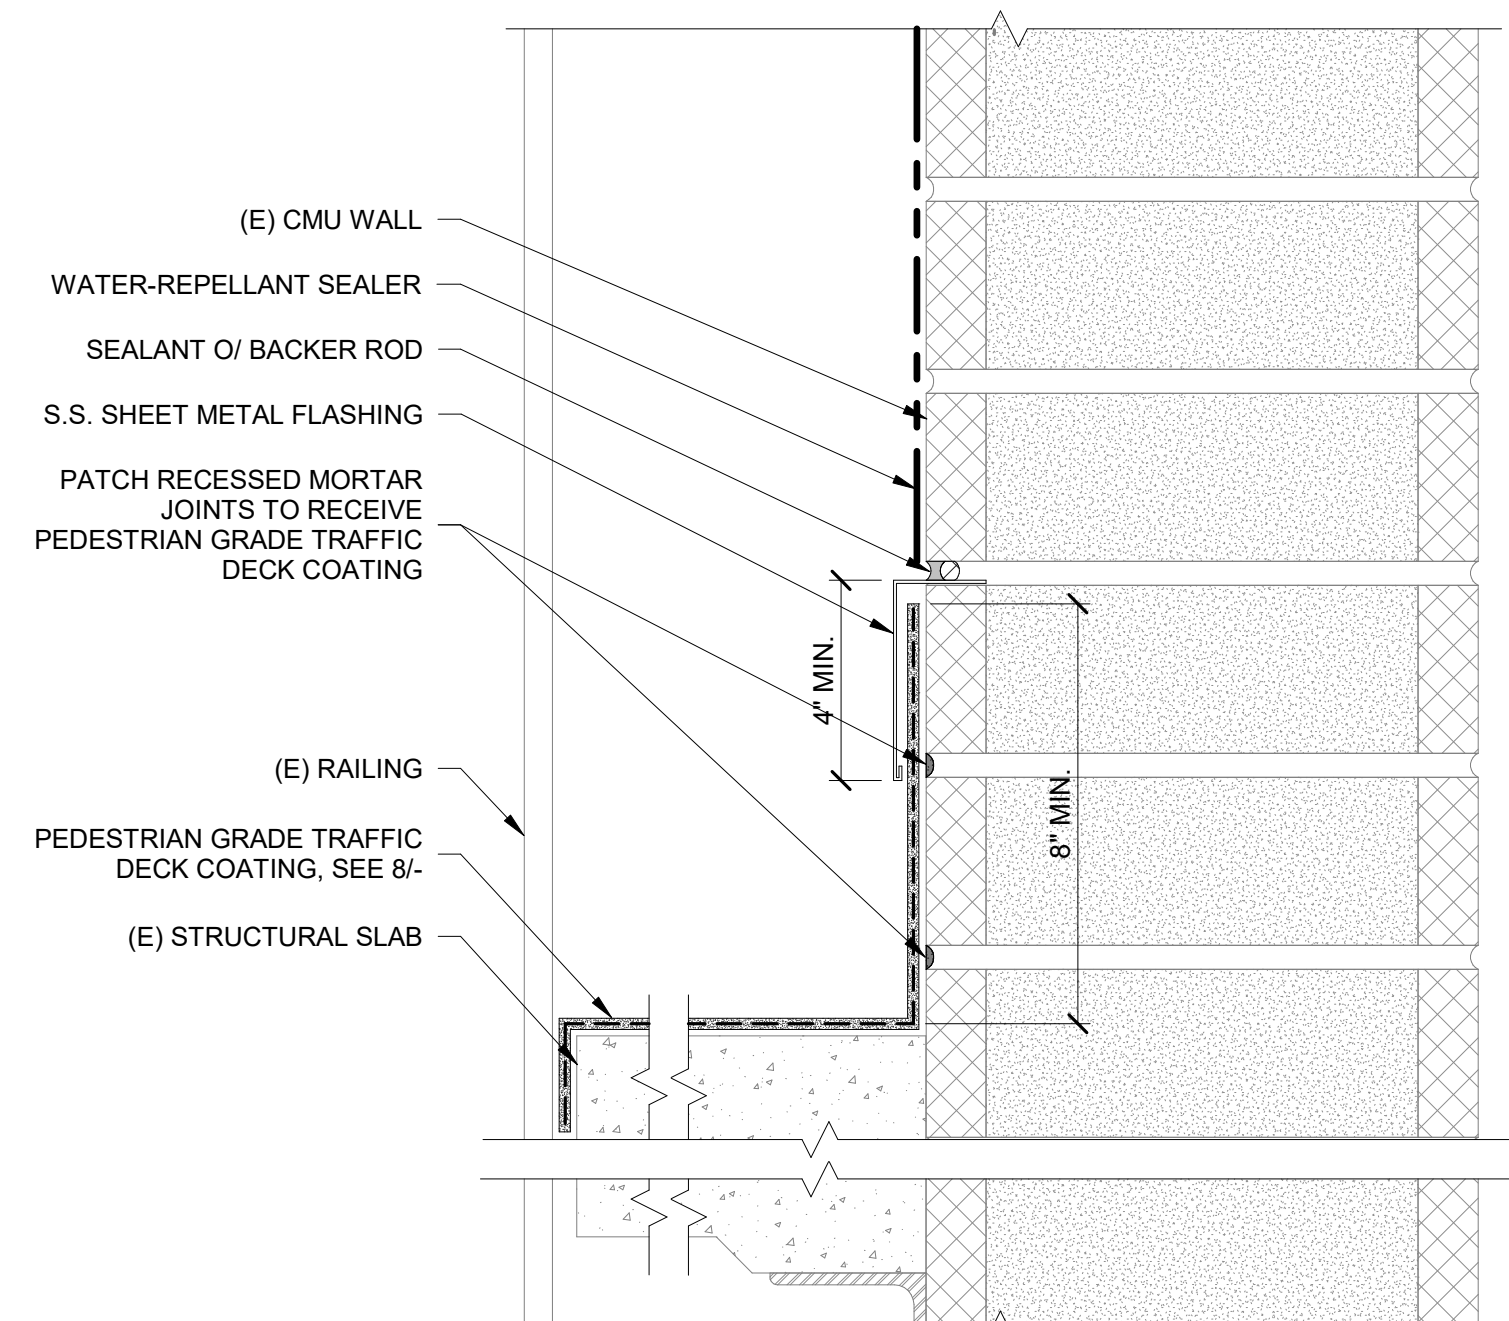
2 SECOND FLOOR CONCRETE LANDING AT CMU WALL
 NTS

- Remove and retain door threshold for reinstallation.
- Install pedestrian-grade traffic deck waterproofing coating on the second floor landing. Extend the coating 8 in. onto the CMU wall.
- Bed the door threshold in sealant onto the traffic deck coating.
- Cut out the horizontal CMU mortar joint above the traffic deck coating upturn. Install new sheet metal flashing kerfed into the removed CMU mortar joint. Install sealant over backer rod between sheet metal flashing and CMU. Refer to details on Sheet W804.

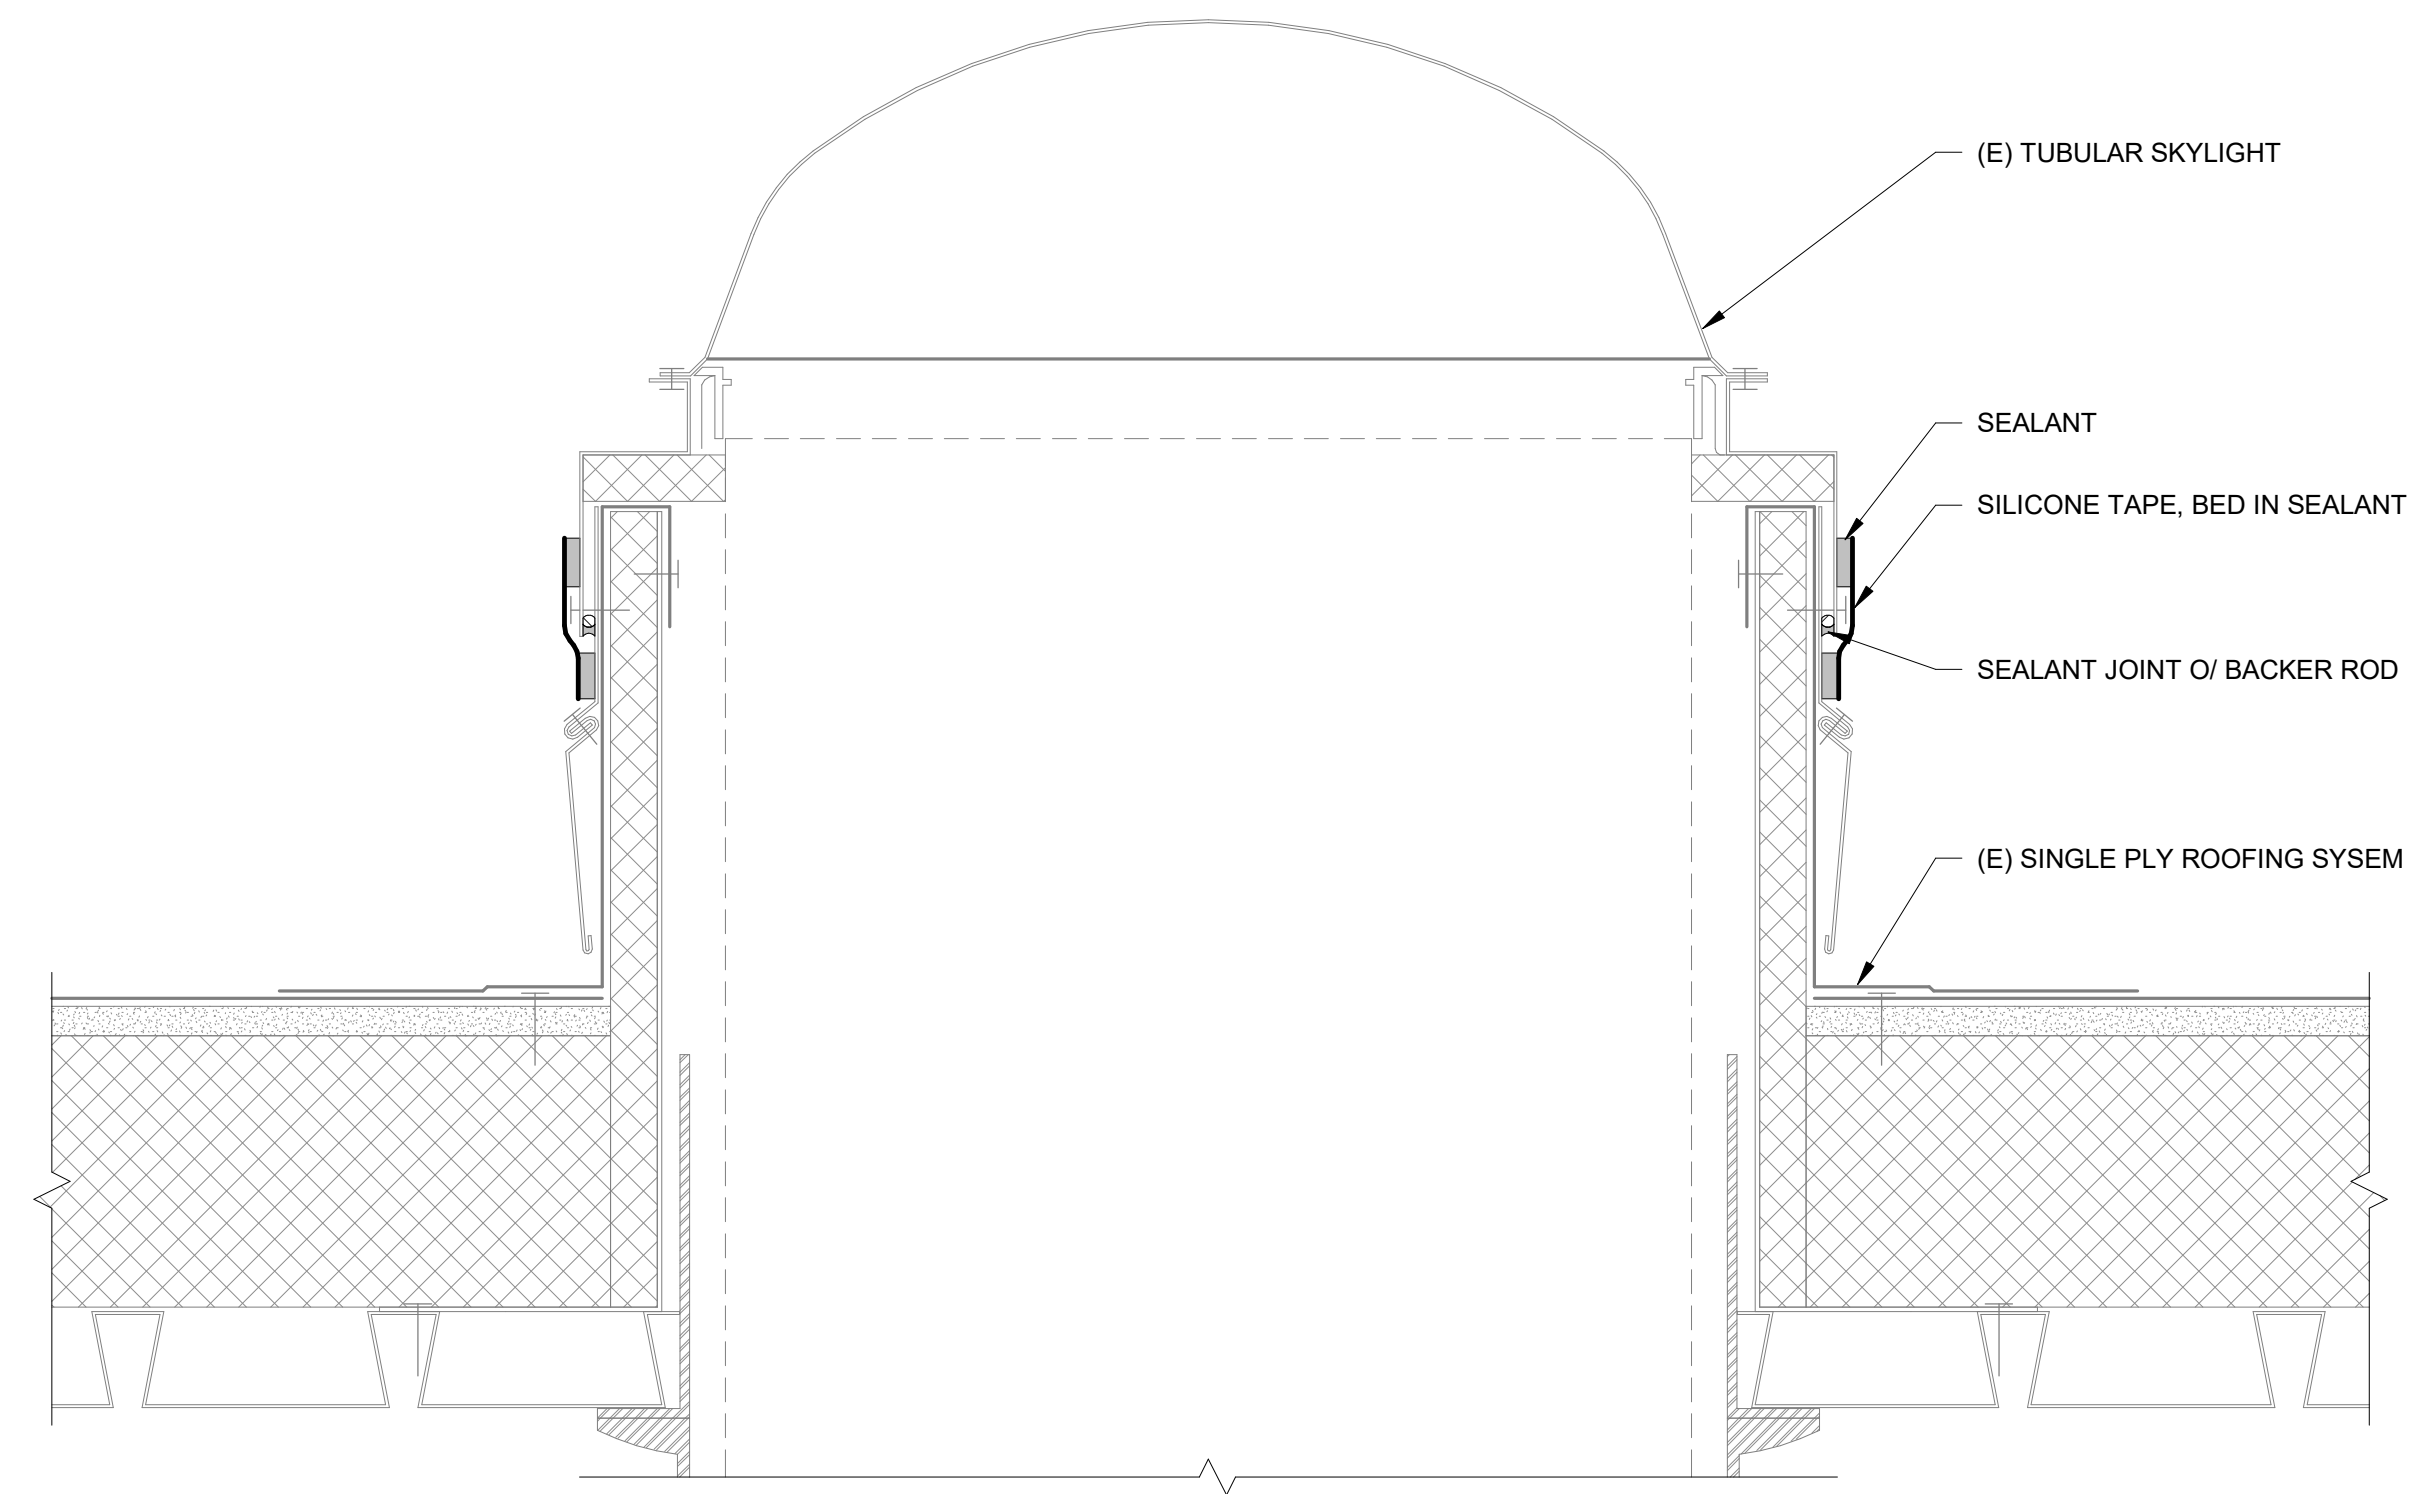
3 ROOF SKYLIGHT
 NTS

- Install silicone tape bed in silicone sealant to seal the transition between skylight and roofing sheet metal counterflashing. Refer to Detail 3/W804.

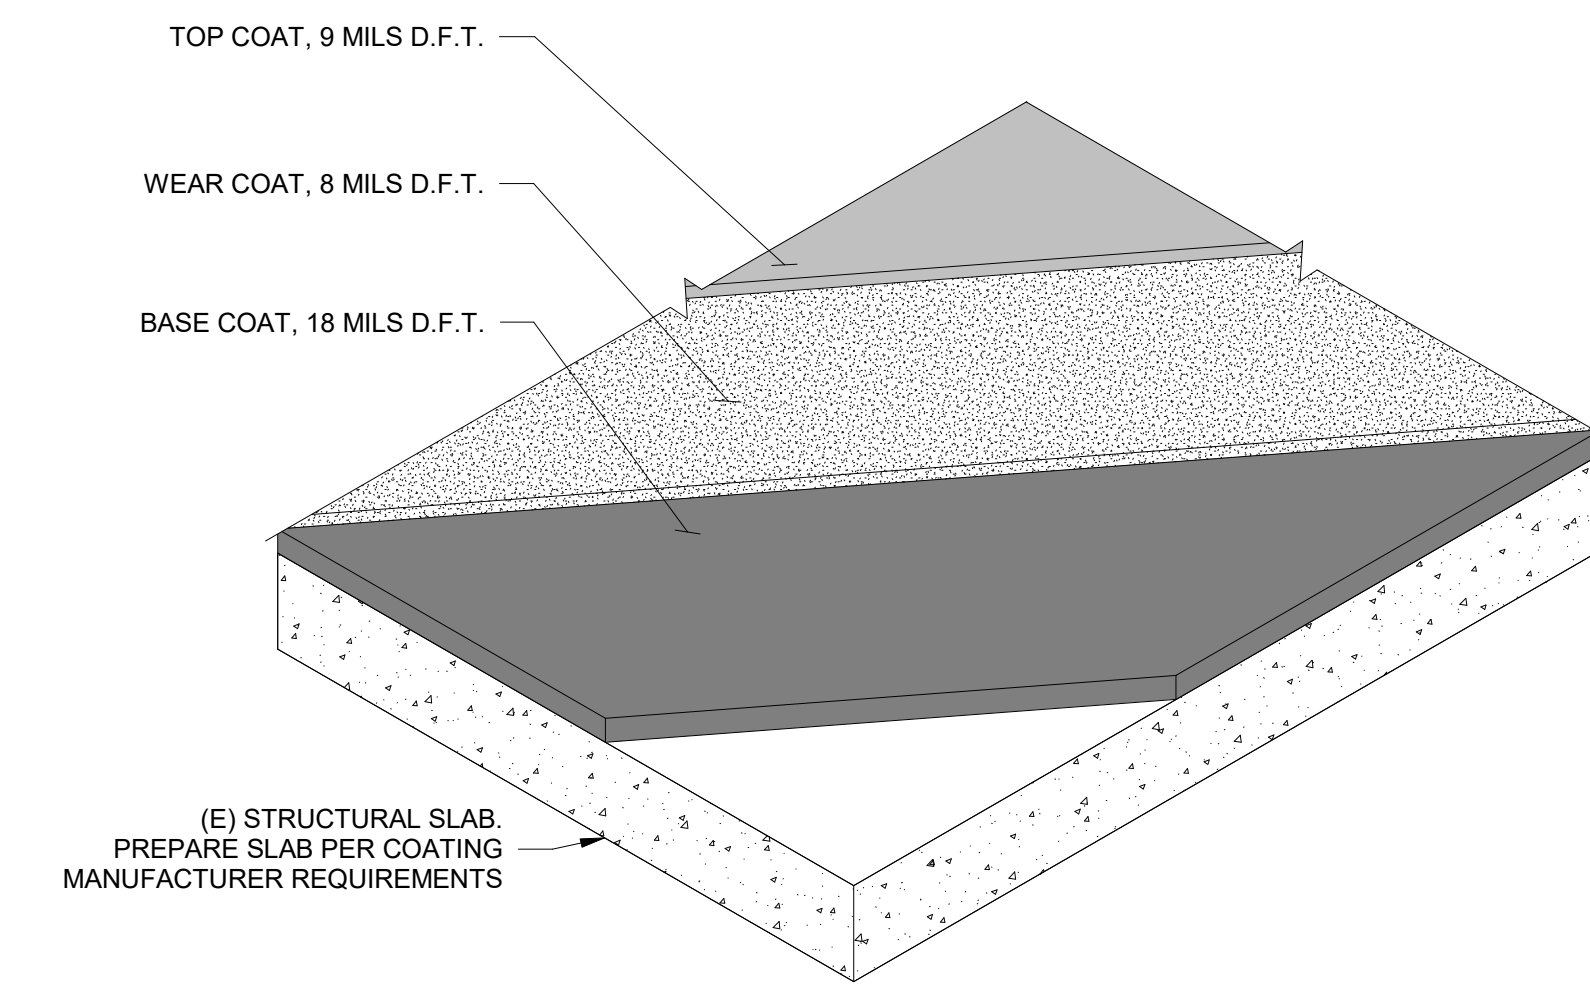
8 TRAFFIC DECK COATING SYSTEM
 NTS

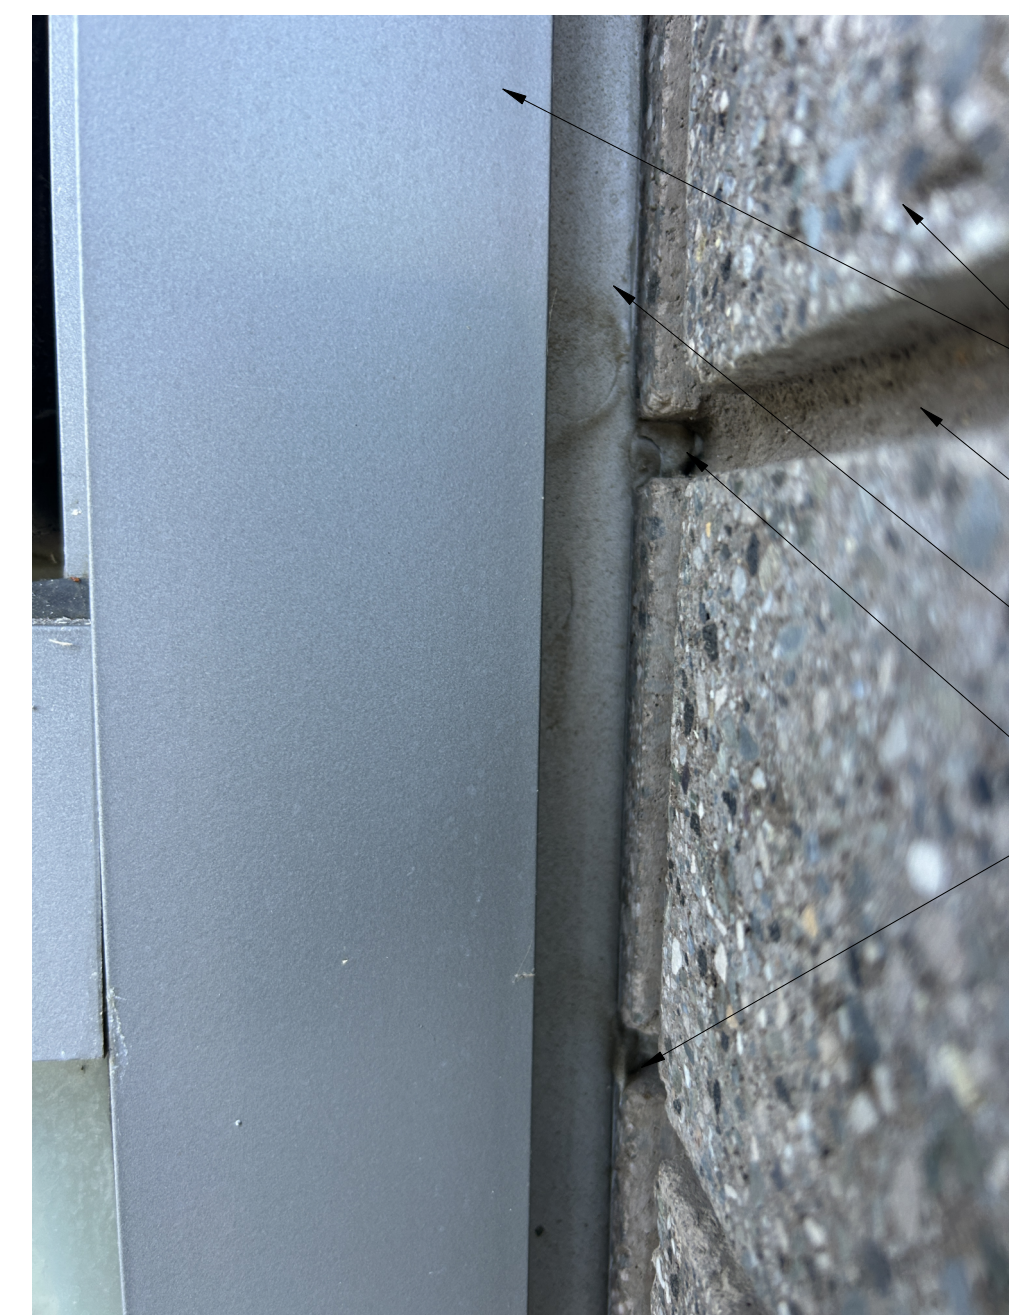
(E) CMU WALL AND ADJACENT FINISH
 (E) RECESSED CMU MORTAR JOINT
 SEALANT O/ BACKER ROD, REPLACE BASED ON SURVEY
 INFILL SEALANT AT RECESSED CMU MORTAR JOINTS

9 PERIMETER SEALANT AT RECESSED MORTAR JOINT
 NTS

- Survey 100% of sealant joints between the CMU walls and adjacent finishes. Submit survey to the Engineer-of-Record.
- Remove and replace all portions of sealant with defects. Defects include, but are not limited to, voids and incompletely adhered sealant locations.
- Extend the replacement area 6 in. in both directions beyond the identified defect locations.
- Infill sealant at recessed CMU mortar joints to form continuous perimeter sealant. Refer to Detail 9/W804.
